# Removing the RF(capacitor) modification

Between mid 2018 to mid 2019 a small capacitor was added to MS2000, RM2000 controllers to reduce RF emissions. When this capacitor fails it grounds the oscillator preventing the microcontroller from running. The controller doesn't respond to serial/usb input, joystick, knob and the LCD is blank or full of bars.

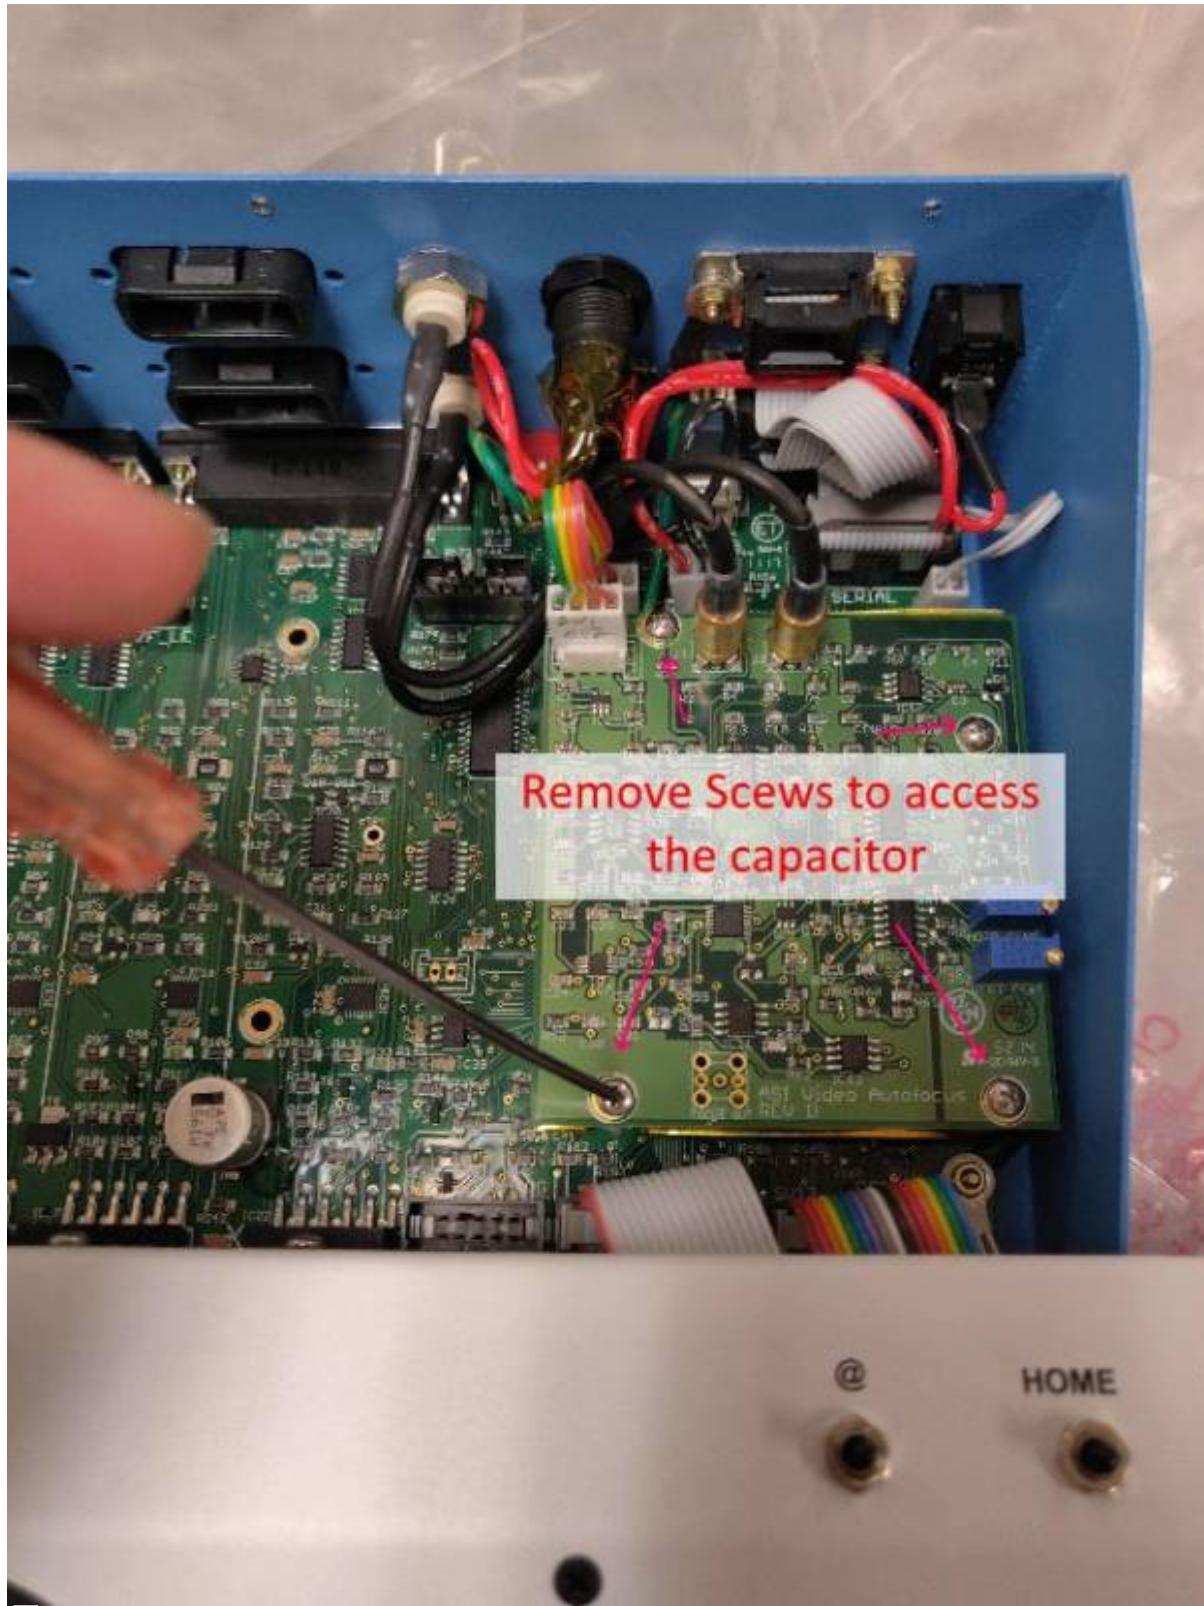
Some controllers might have an add-on card like the autofocus or crisp system blocking access to the capacitor. Unmount it by unscrewing the four screws holding it in place.

Remove add-on card

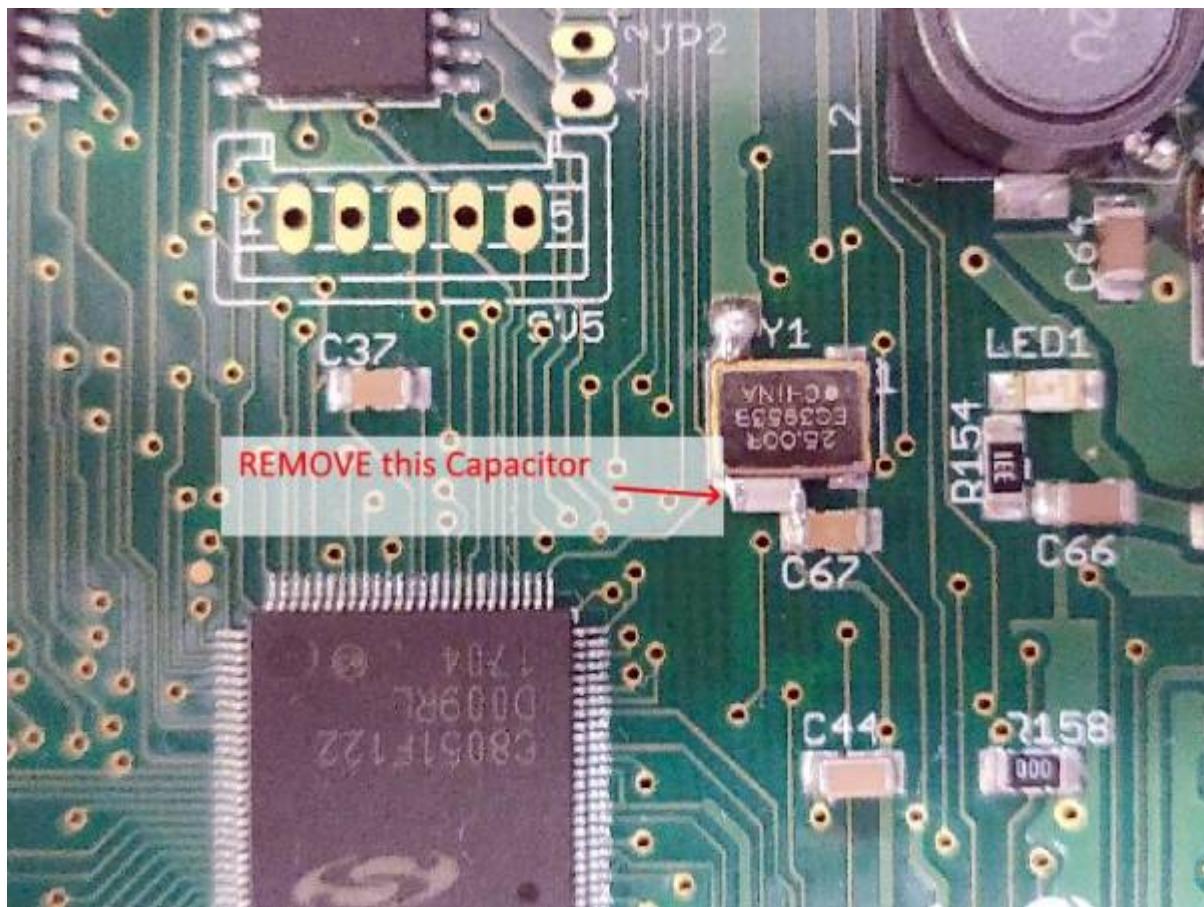
Remove the white capacitor

They are bypass caps, the system can work without them. But if they are broken, they short the voltage rails and prevent the system from booting. Hopefully, the power regulators onboard haven't failed.

Then look for the oscillator Y1, next to it are two capacitors, one white and another mustard color. Remove the white capacitor (refer to the attached picture) with soldering iron, you may have to remove the mustard one as well.

Then power the controller and test it, if it doesn't work, put the mustard one back in and test it again.

If that didn't work either the board might be more damaged, contact ASI to arrange an RMA.
