Synchronous Encoder Reporting

TTL Report Module

This section of the manual applies to the TTL_REPORT_INT firmware module. Including this module in the firmware allows for precisely synchronized encoder position reporting. The user's hardware supplies a TTL trigger to the MS-2000 that causes a processor interrupt which performs an encoder-read operation on all of the controller's motorized axes. Any firmware build that includes this module is not capable of any other TTL input modes and will only perform the functionality of the TTL_REPORT_INT module.

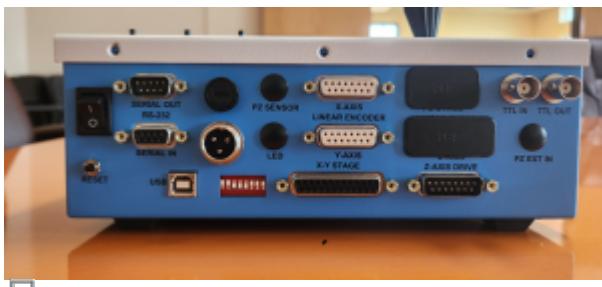
A standard MS-2000 with RS-232 **SERIAL OUT**

As you can see in the image, this MS-2000 has the serial port connector. You may have a controller configured for CRISP that replaces this port with a male DB9 connector. In that case, you will need to

To use the optional SERIAL_OUT module, the controller requires the RS-232 **SERIAL OUT** port on the back of the MS-2000, this feature uses the second serial port to output the report.

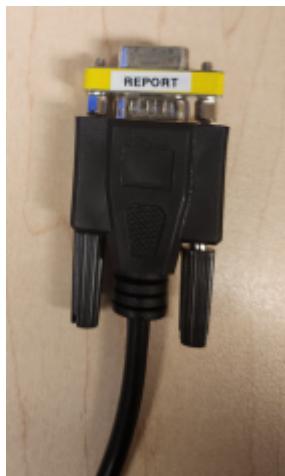
Straight through serial cable with gender changer

You will also need a straight through serial cable (not a null modem cable) with a gender changer to connect the **SERIAL OUT** to the input of the serial port on another computer.

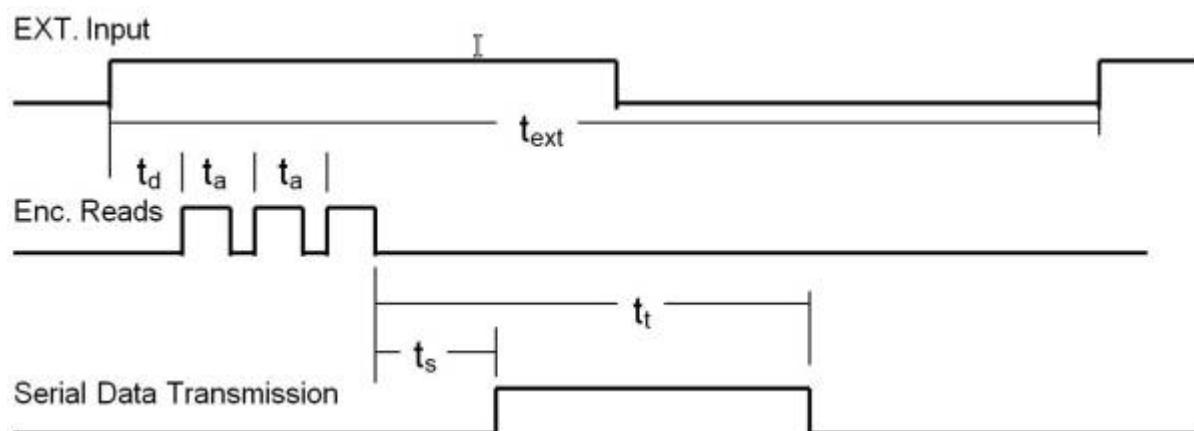
Timing Specifications

Item	Symbol	Spec. Values		Unit
		Min	Max	
Initial Read Delay	t_d	3.0	10.0	μs
Successive Axis Read Delay	t_a	11	13	μs
Serial Transmit Delay	t_s	110	500	μs
Transmit Time†	t_t	1.2	1.75	ms
External re-trigger time†	t_{ext}	1.7		ms

(†) 115200 baud, three axes

The encoder read operations follows the external trigger input as indicated in the timing diagram. The largest jitter component comes from the delay in executing the interrupt service routine that performs the read operations. Most of the time the interrupt proceeds with the minimum delay time specified. Occasionally, the reads are delayed until current data bus operations complete.
