# Leica DMIRB Microscope Z Drive Installation Procedure

The procedure below outlines the steps necessary to install the ASI Microscope Focus Controller Drive onto the Leica DMIRB microscope.

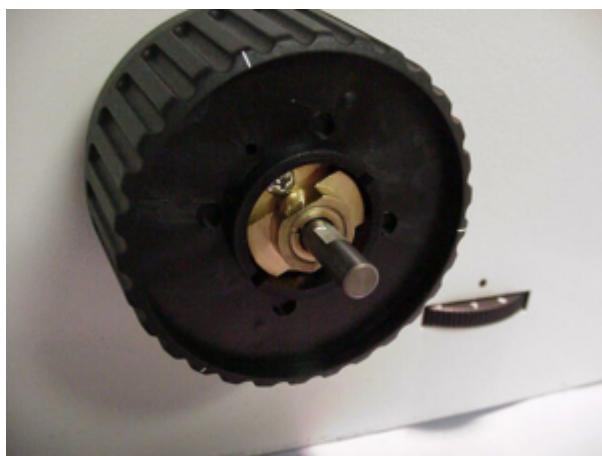
Figure 1. Left Fine Focus Knob Removed

- a) Use the 1.5mm Allen wrench to loosen the setscrew located on the fine focus knob and pull the knob off of the microscope

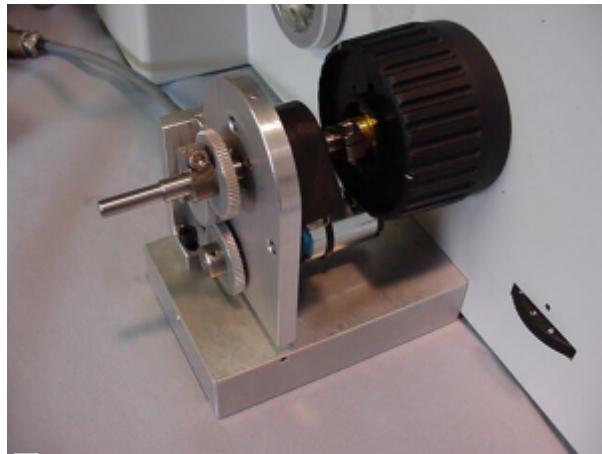
Figure 2. ASI Drive Installed on Leica DMIRB Microscope

The ASI motor drive attaches to the silver horizontal adjustment bar that is attached to the base plate. The motor drive slides within two lips on either side of the horizontal adjustment bar so that it can slide along the vertical axis and is secured to the adjustment bar via two 4/40 vertical adjustment screws. The adjustment bar is secured to the baseplate with a 4x12mm horizontal adjustment screw. The horizontal and vertical adjustments allow the drive to be correctly positioned so the drive shaft on the ASI motor drive can be slid over the fine focus shaft of the microscope.

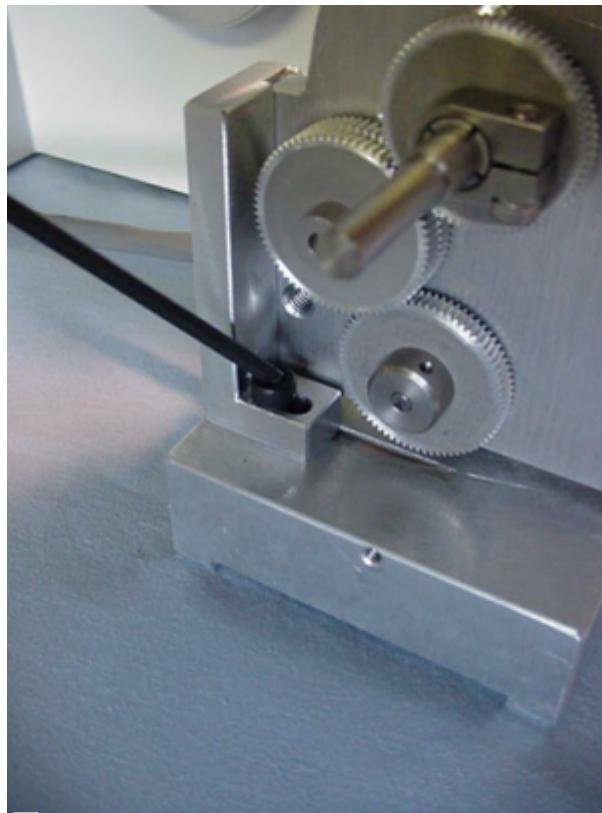
Figure 3. The Horizontal Adjustment Screw

- a) Locate the base plate, the motor drive, adjustment bar, and the Allen wrenches. Use the 3mm Allen wrench to remove the drive assembly from the base plate by removing the horizontal adjustment screw as shown in figure 3.

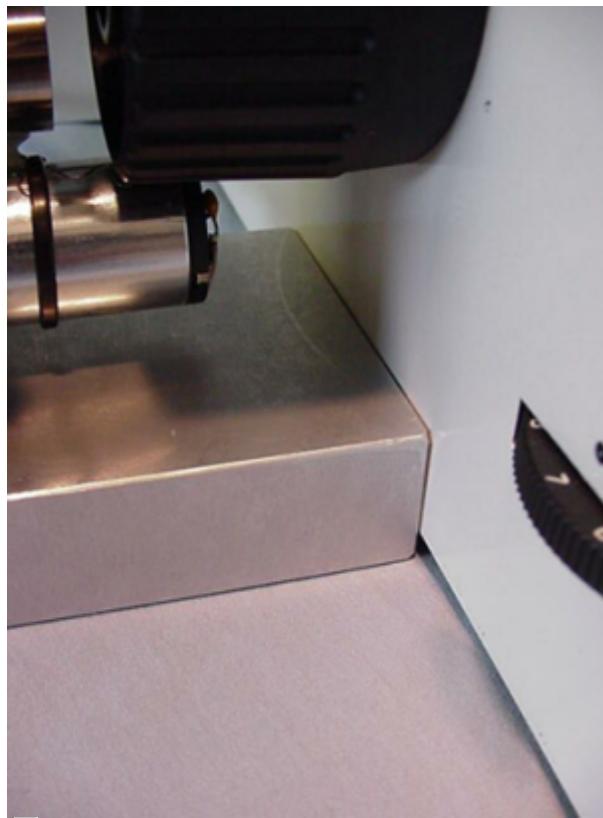
Figure 4. Base plate should be flush with the side of the microscope and about center under the focus knob.

b) Slide the baseplate assembly under the microscope until the baseplate is about centered under the focus knob. Insure that the base plate is parallel with the bottom of the microscope. Position the base plate so that it is under the focus assembly as shown in figure 4.

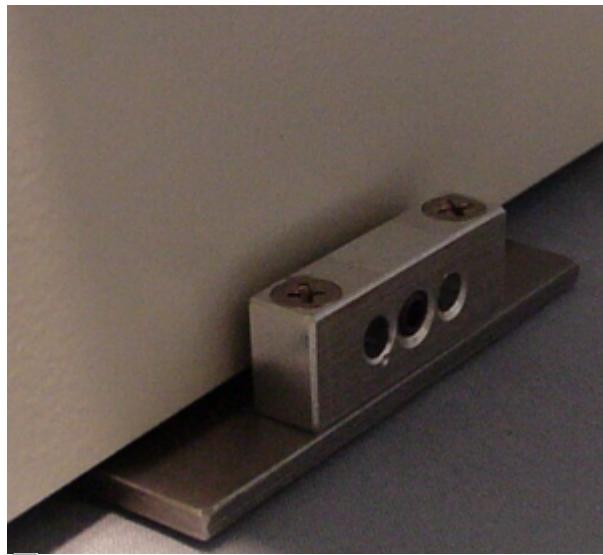
Figure 5. Clamp to tighten base plate to the microscope.

e) Slide the ASI drive shaft clamp towards the microscope body as shown in figure 7, and use the 7/64 inch hex wrench to tighten the drive shaft clamp. Insure that this clamp is securely tightened or slippage may occur. Use the 5/64" Allen wrench to tighten the base plate clamp that is located on the right side of the microscope as shown in figure 5. Tightening this setscrew will cause the silver bar to press against the side of the microscope. Insure that the setscrew is securely tightened to hold the baseplate assembly in place.

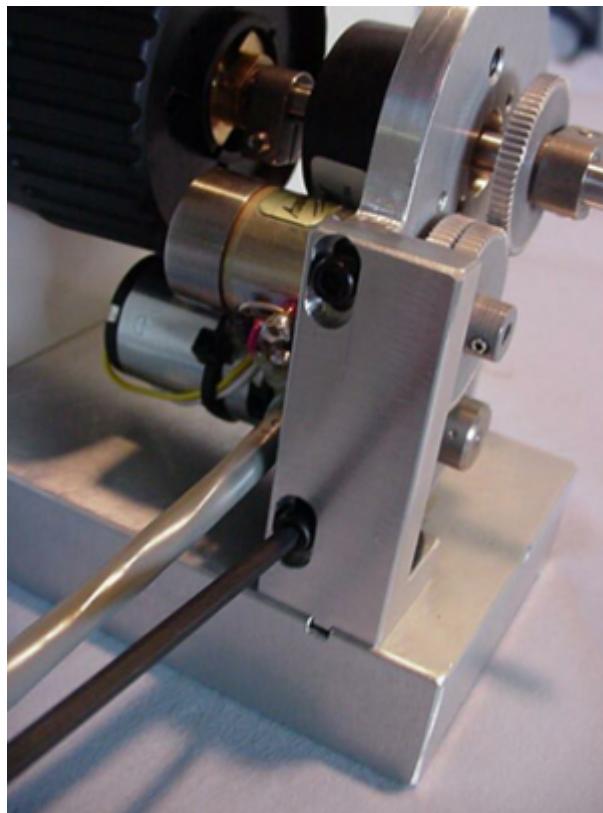
Figure 6. The vertical adjustment screws

c) Locate the adjustment bar, and the motor drive. Use the 7/64" Allen wrench to loosen the vertical adjustment screws as shown in figure 6. Use the 7/64 Allen wrench to loosen the clamp that is located on the ASI drive shaft as shown in Figure 7. This clamp is located at the end of the drive shaft as it protrudes out of the black encoder cover. Once the clamp is loose slide it back towards the encoder. While holding the right fine focus knob with one hand align the ASI drive shaft with the microscope's fine focus shaft and slide the ASI drive shaft over the microscope's fine focus shaft. If you do not hold

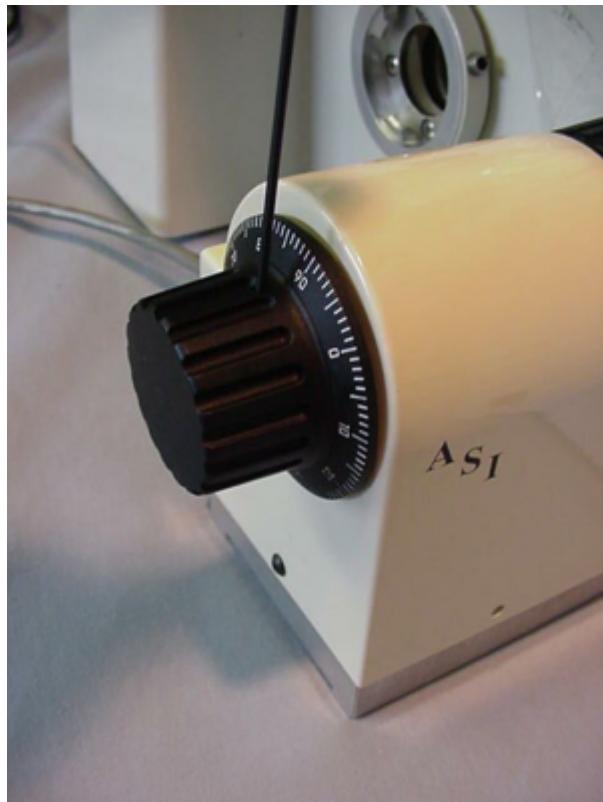
Figure 8. Installing the cover & the fine focus knob

a) Locate the motor drive cover. Remove the 4/40 button head screws from the drive with the 1/16 " Allen wrench. Position the motor drive cover over the motor drive assembly and secure in place using the 4/40 buttonhead screws.

b.) Slide the microscope's fine focus knob over the shaft and secure it in place by using the 1.5 mm Allen wrench to tighten the set screw. Please note that the knob should be positioned so that it does not rub against the cover.
